**POHAKEA WATERSHED / MA ALAEA BAY  
MAUI COUNTY, HAWAII  
STORMWATER MANAGEMENT PLAN**

Maui Nui Marine Resource Council

November 16<sup>th</sup>, 2018

**Maui Environmental Consulting, LLC  
PO Box 790568  
Paia, HI 96779 • 808-866-6919**

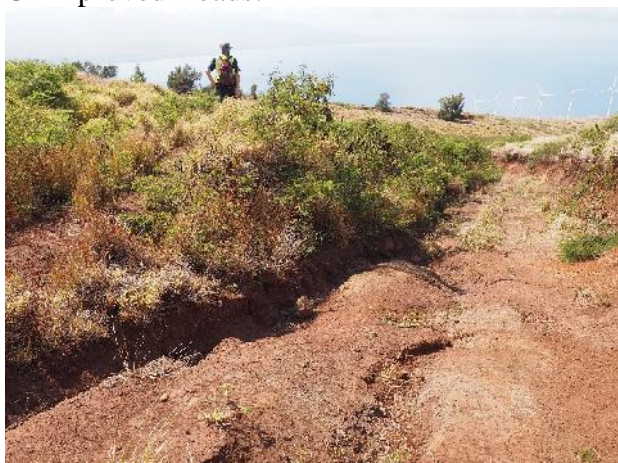
Road Channelization

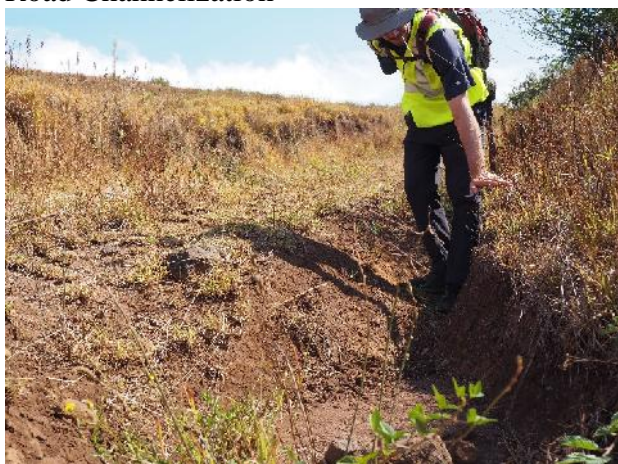
Road Channelization

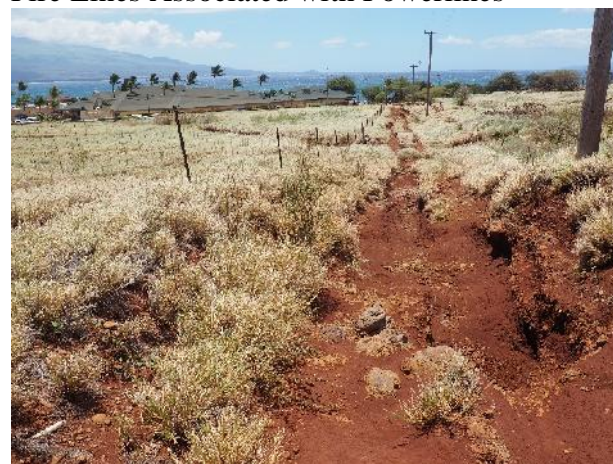
Distribution Lines and Failed Roads

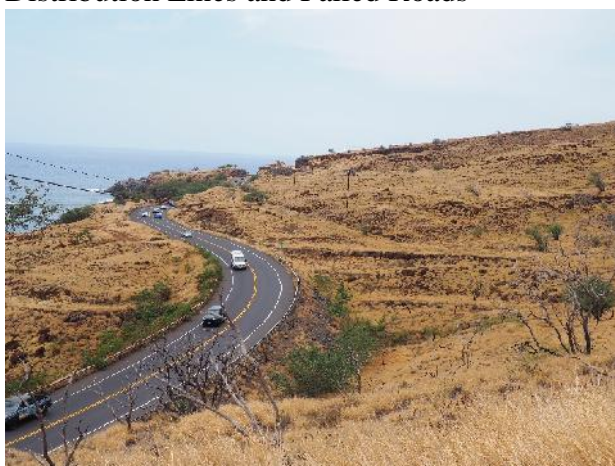
Distribution Lines and Failed Roads

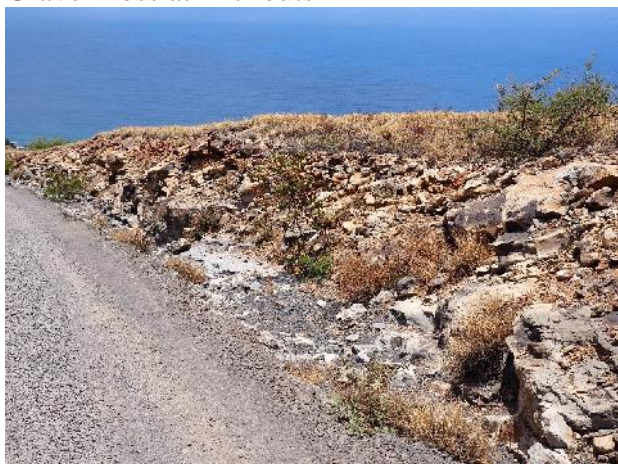
Channelization and Gravel Loss in Swale

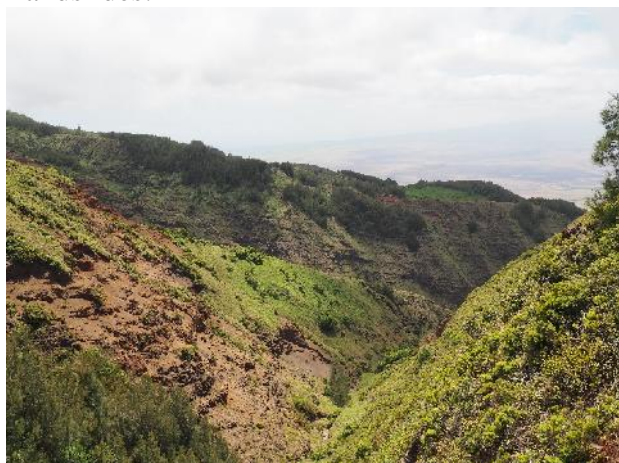
Loss of Vegetation

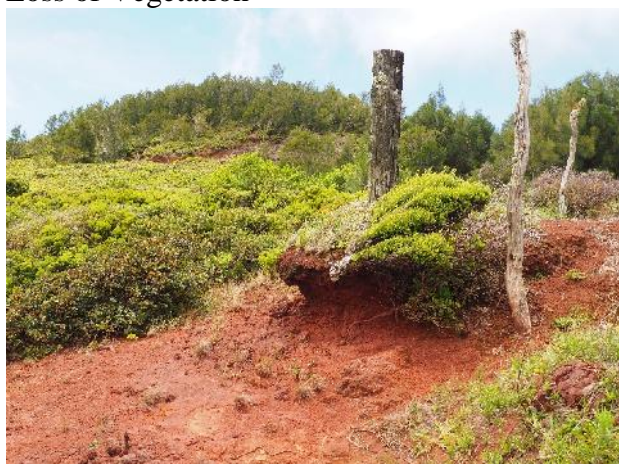
Soil Loss and Remaining Vegetation

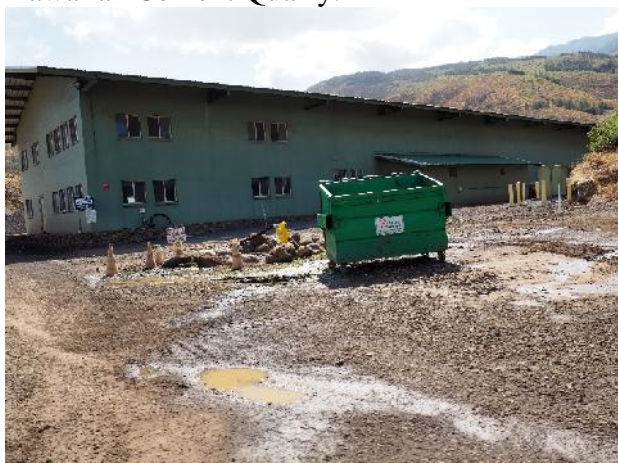
Gravel Roads with Mud and Erosion

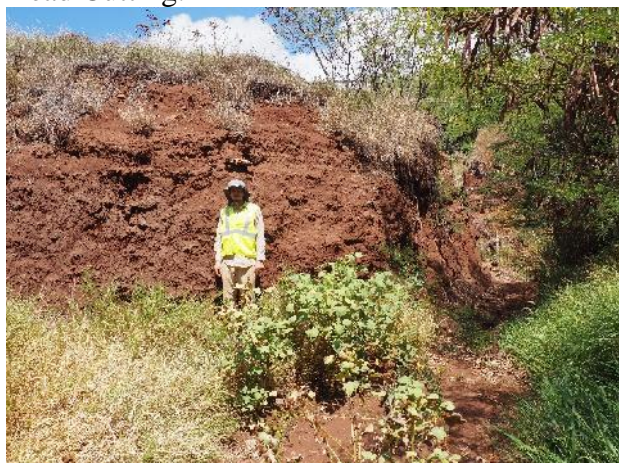
Head Cutting

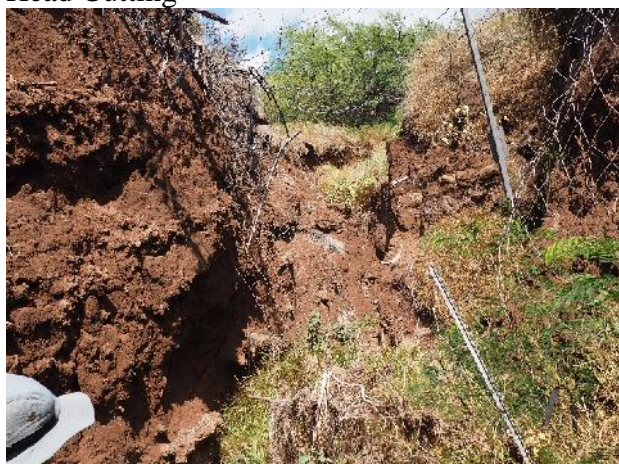
Channelization

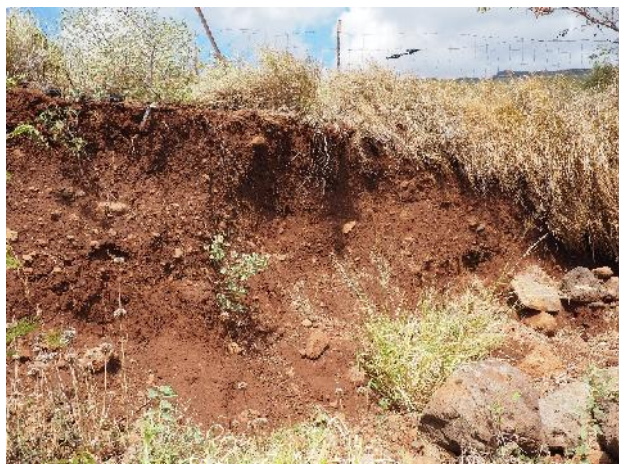
Head Cutting

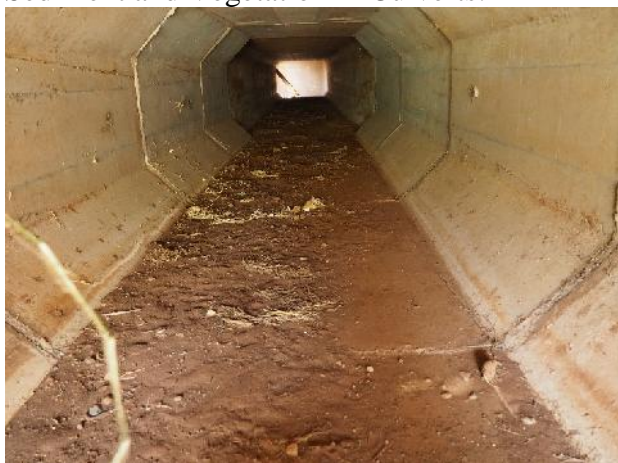
Sediment in Culverts

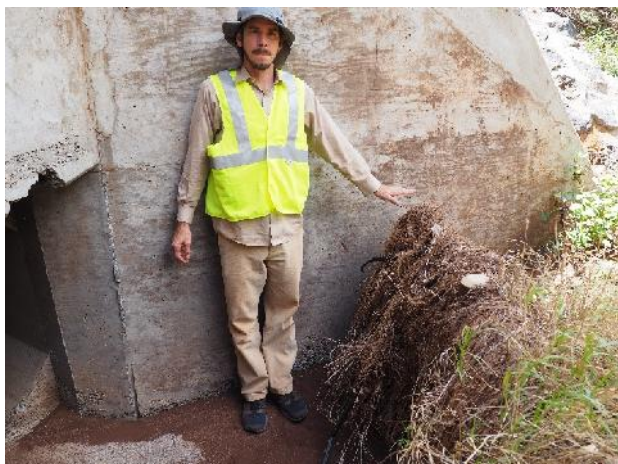
Extent of Vegetation at Entrance to Culvert

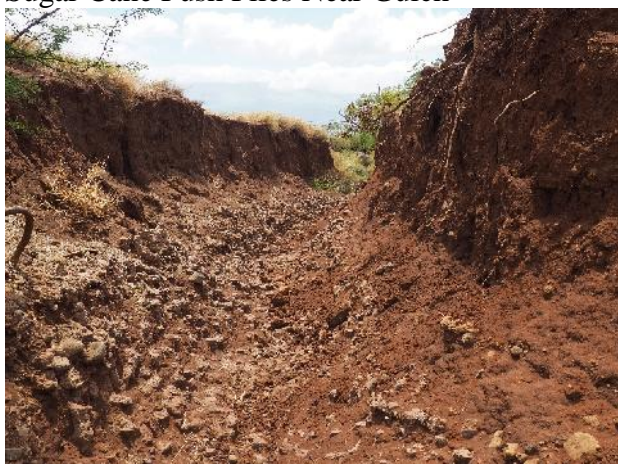
Highly Eroded Stream Channel

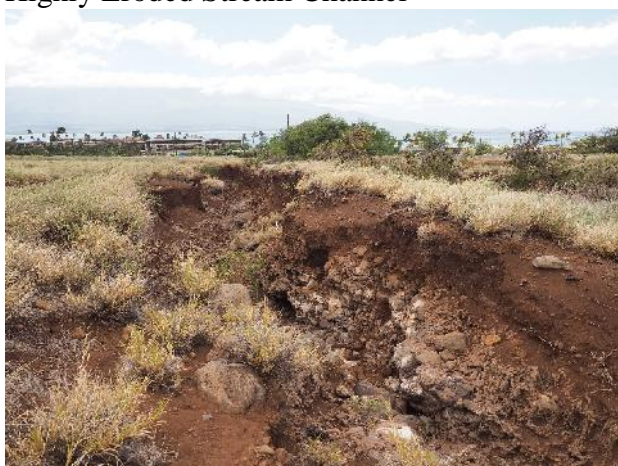
Highly Eroded Stream Channel

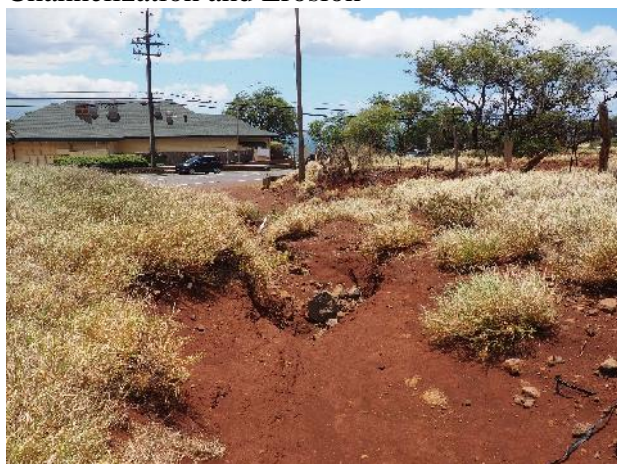
Failed Road with Channelization and Erosion

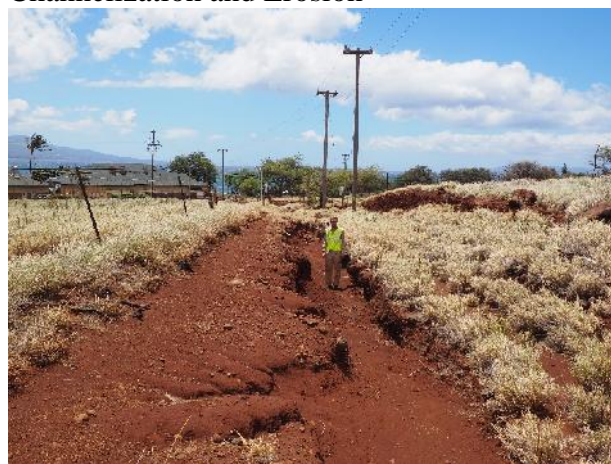
Failed Road with Channelization and Erosion

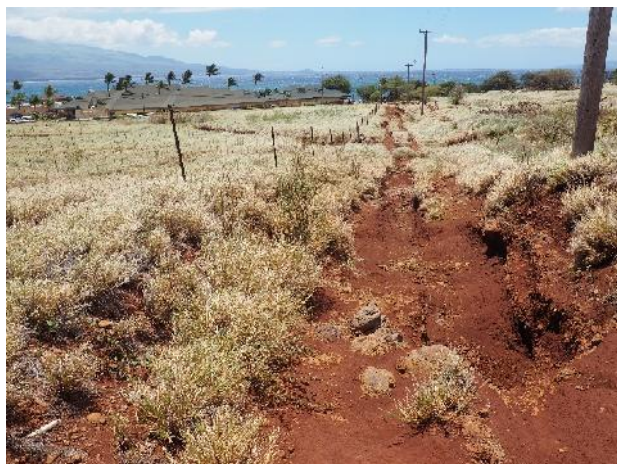
Failed Road with Channelization and Erosion

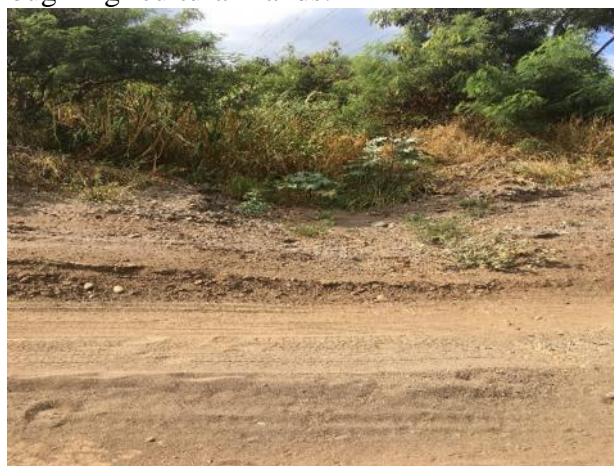
Road Crossing Pohakea Lacking BMPs

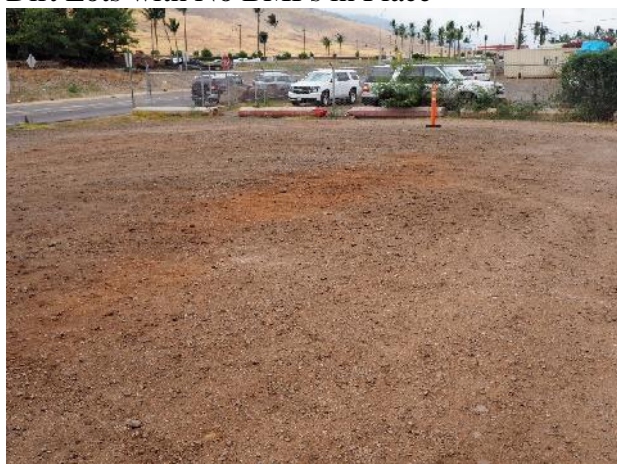
Dirt Lots with No BMPs in Place

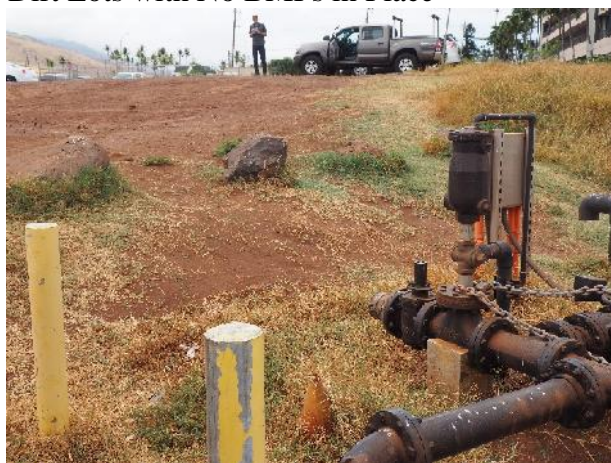
Dirt Lots with No BMPs in Place

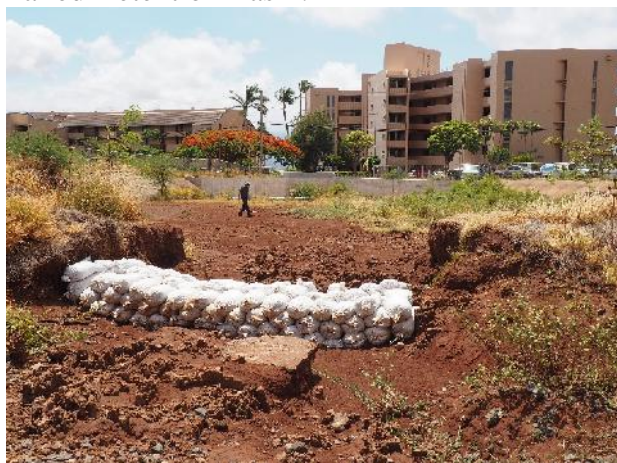
There is a failed detention basin mauka of Hau'oli Street and the Maui Island Sands Resort. Constructed following the major storms in September and December of 2016, this detention basin receives the flows from Kanaio Stream as well as several other unnamed streams representing a significant concentration point of stormwater flow from the landscape within the project area (Discharge Locations Map). Based on the observed failure, it is assumed the basin's size and construction are inadequate to handle the substantial flows it receives. This is evidenced by extensive head cutting and channel incision above the basin, and a breached control structure that divides the basin. This structure is a compacted earth and gravel berm that was intended to temporarily detain stormwater, and gradually release it through PVC stand pipes directed into the lower portion of the basin. The breach occurred at the center of this berm, directly in line with the point at which the stream enters the basin, indicating a high flow stream event which punched through the control structure carrying gravel and sediment material under Hau'oli Street, down a concrete lined channel, and into the ocean between Maui Island Sands Resort and the Ma'alaea Banyans. This basin, its associated head cut, and the failed control structure, all represent sediment sources in the flow path waiting for the next storm to be transported to the ocean each time the stream flows.

Sand Bags at Failed Control Structure

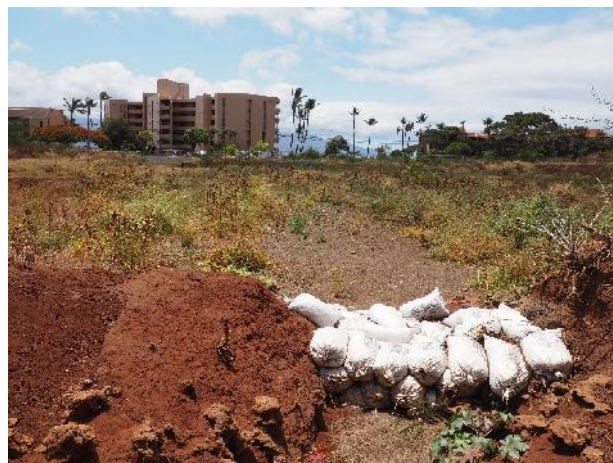
Sand Bags at Channel Outfall to Detention Basin

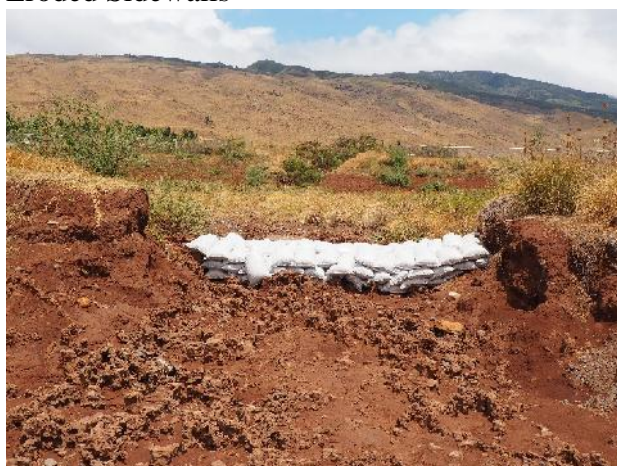
Failed Control Structure

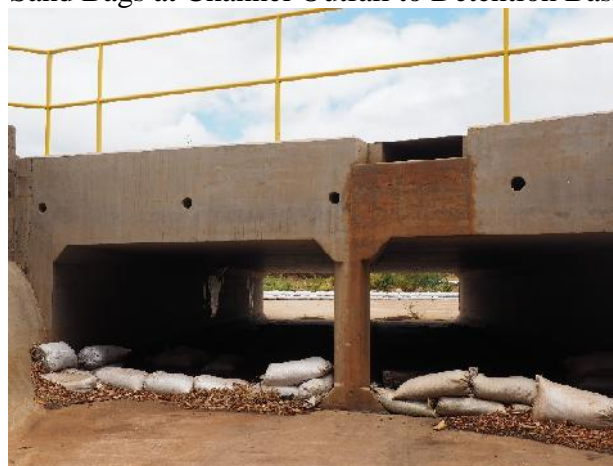
Sand Bags Under Hau'oli Street
