**POHAKEA WATERSHED / MA ALAEA BAY  
MAUI COUNTY, HAWAII  
STORMWATER MANAGEMENT PLAN**

Maui Nui Marine Resource Council

November 16<sup>th</sup>, 2018

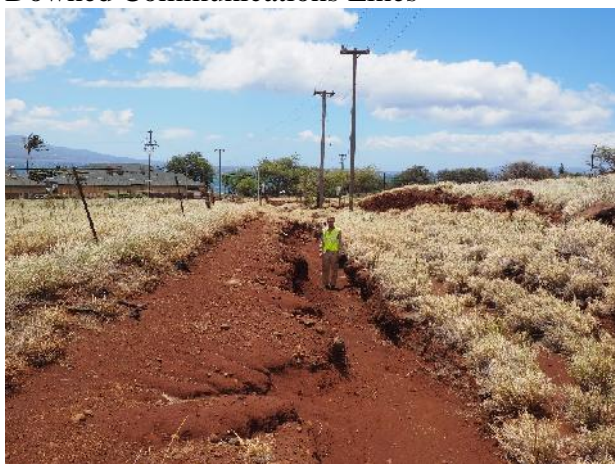
Distribution Lines and Failed Roads

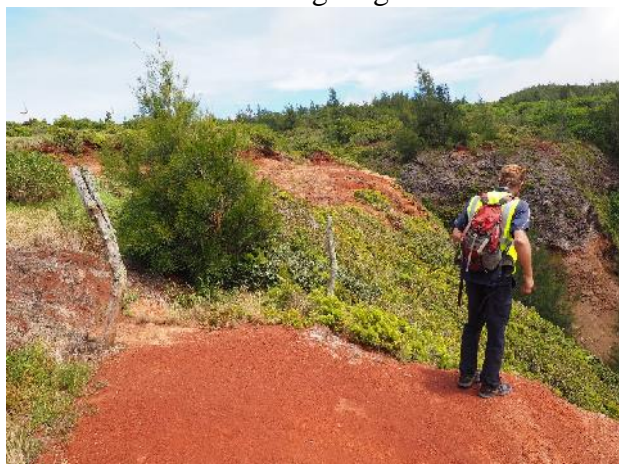
Bare Ground Areas

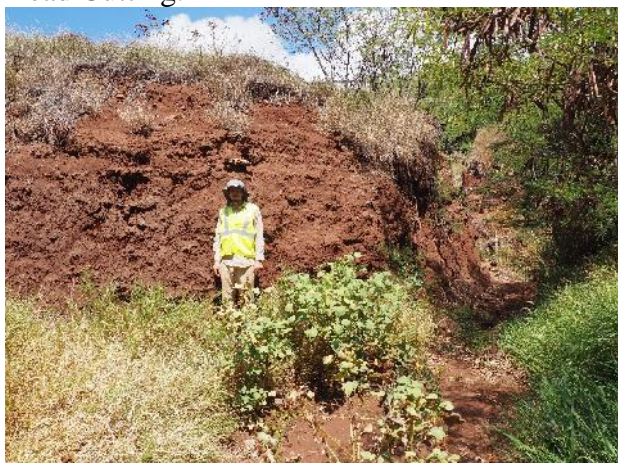
Head Cutting

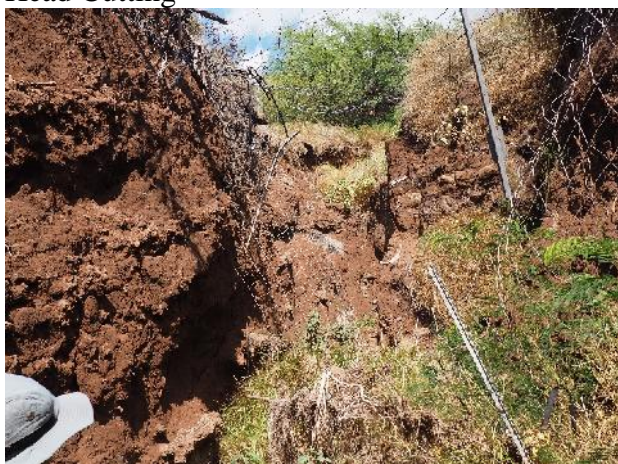
Channelization

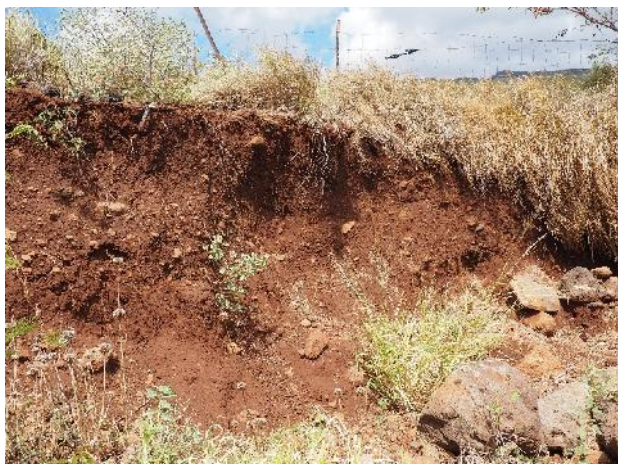
Head Cutting

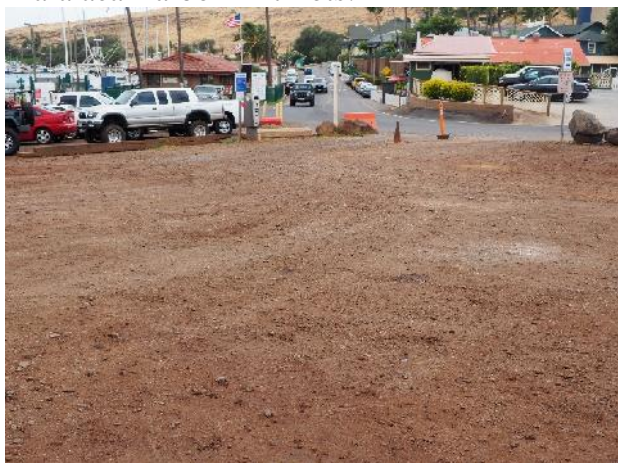
Dirt Lots with No BMPs in Place

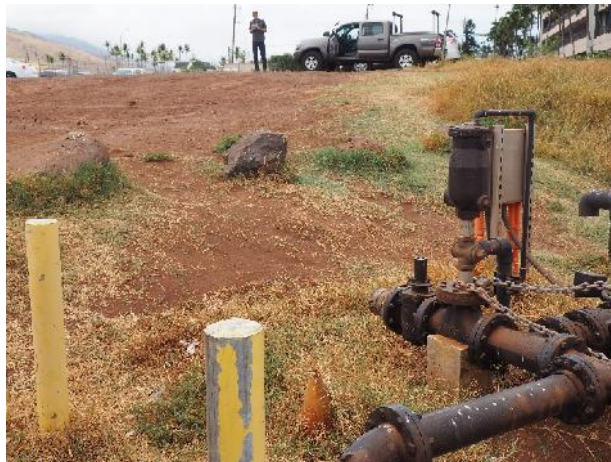
Dirt Lots with No BMPs in Place

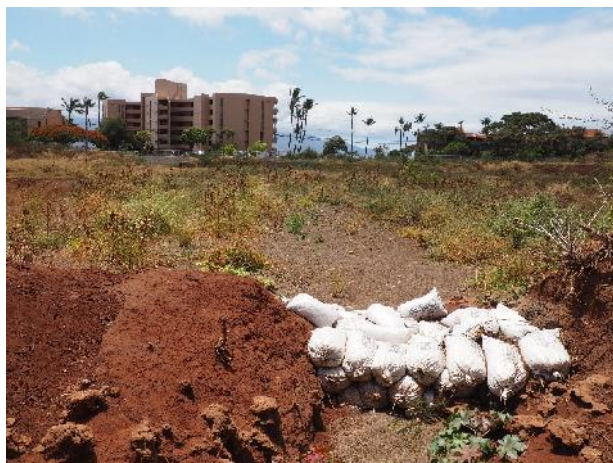
Sand Bags at Channel Outfall to Detention Basin

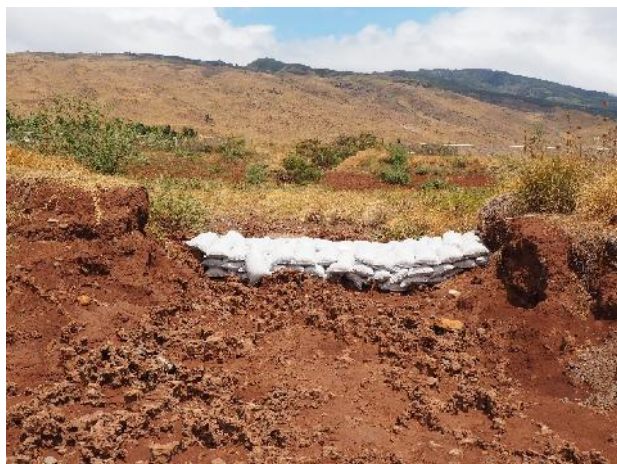
There is a failed detention basin mauka of Hau'oli Street and the Maui Island Sands Resort. Constructed following the major storms in September and December of 2016, this detention basin receives the flows from Kanaio Stream as well as several other unnamed streams representing a significant concentration point of stormwater flow from the landscape within the project area (Discharge Locations Map). Based on the observed failure, it is assumed the basin's size and construction are inadequate to handle the substantial flows it receives. This is evidenced by extensive head cutting and channel incision above the basin, and a breached control structure that divides the basin. This structure is a compacted earth and gravel berm that was intended to temporarily detain stormwater, and gradually release it through PVC stand pipes directed into the lower portion of the basin. The breach occurred at the center of this berm, directly in line with the point at which the stream enters the basin, indicating a high flow stream event which punched through the control structure carrying gravel and sediment material under Hau'oli Street, down a concrete lined channel, and into the ocean between Maui Island Sands Resort and the Ma'alaea Banyans. This basin, its associated head cut, and the failed control structure, all represent sediment sources in the flow path waiting for the next storm to be transported to the ocean each time the stream flows.

Failed Control Structure

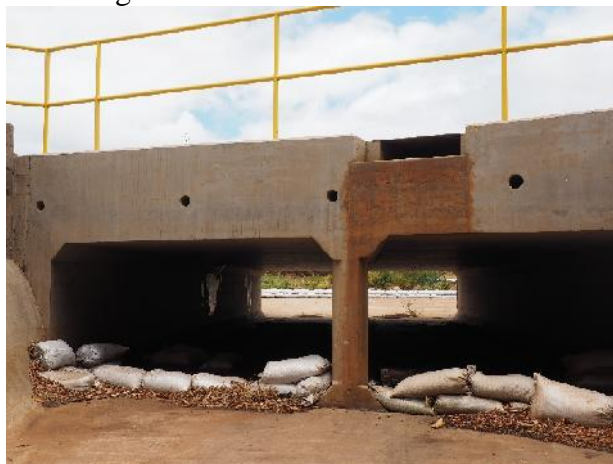
Sand Bags Under Hau'oli Street
