**POHAKEA WATERSHED / MA ALAEA BAY  
MAUI COUNTY, HAWAII  
STORMWATER MANAGEMENT PLAN**

Maui Nui Marine Resource Council

November 16<sup>th</sup>, 2018

**Maui Environmental Consulting, LLC  
PO Box 790568  
Paia, HI 96779 • 808-866-6919**

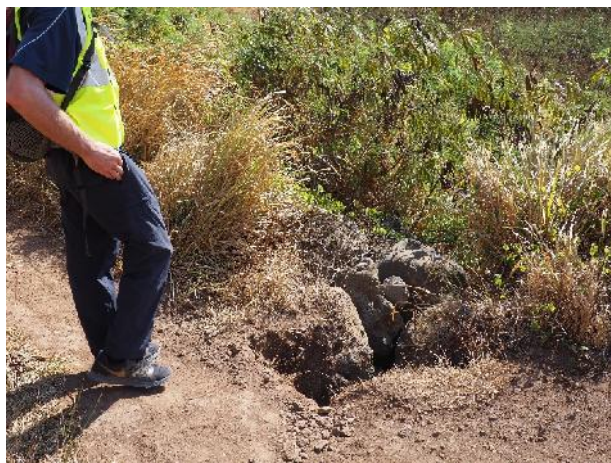
Erosion and Discharge from Road

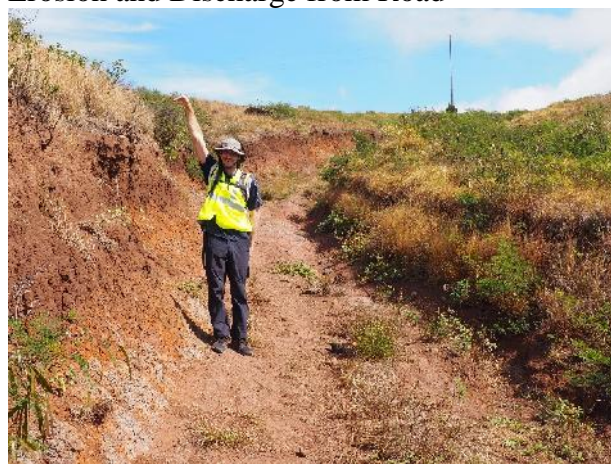
Exposed Soil Along Road

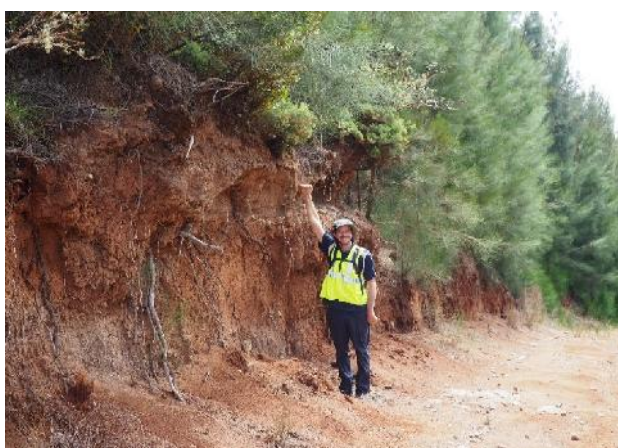
Exposed Soil Along Road

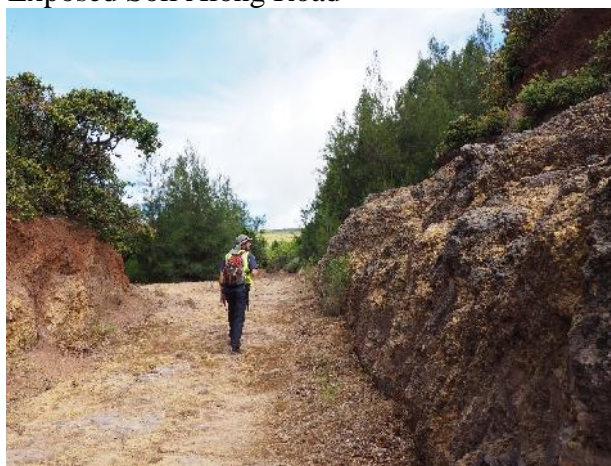
Exposed Soil Along Road

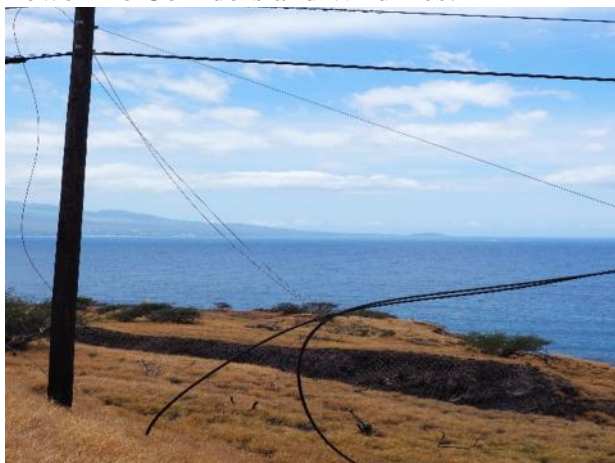
Downed Communications Lines

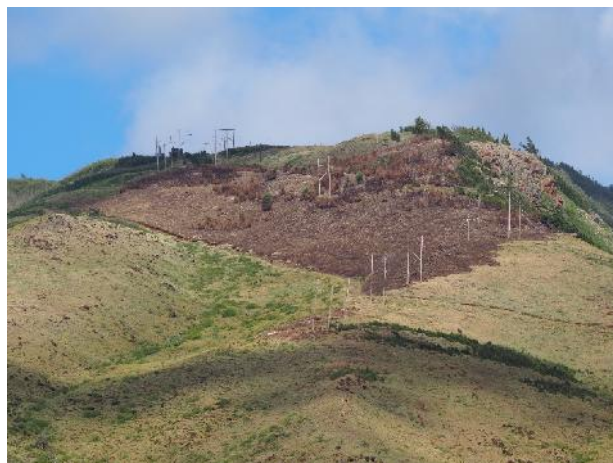
Fire Lines Associated with Powerlines

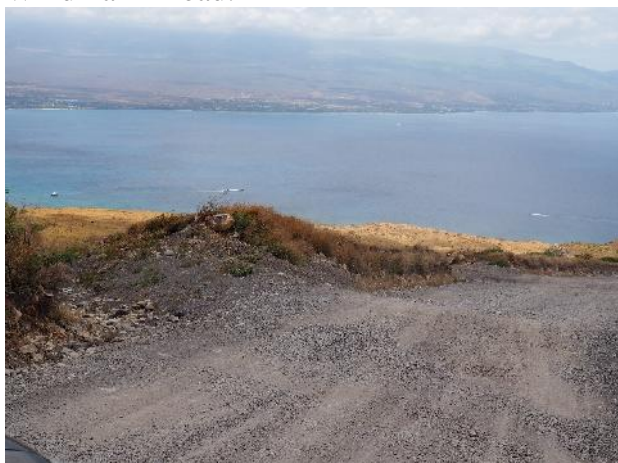
Water Bars and Kickouts

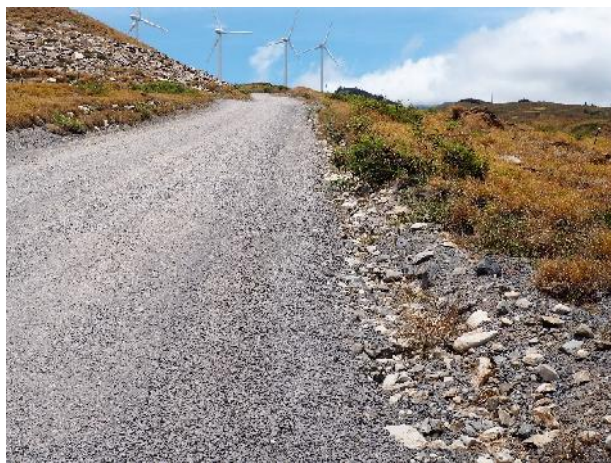
Well Maintained Road with Swale

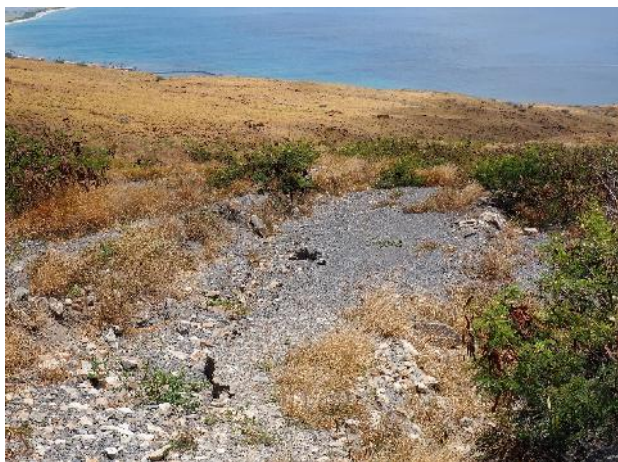
Gravel Loss at Kickouts

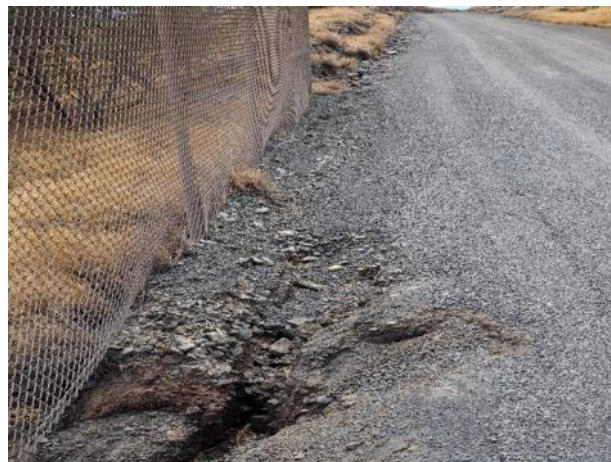
Erosion

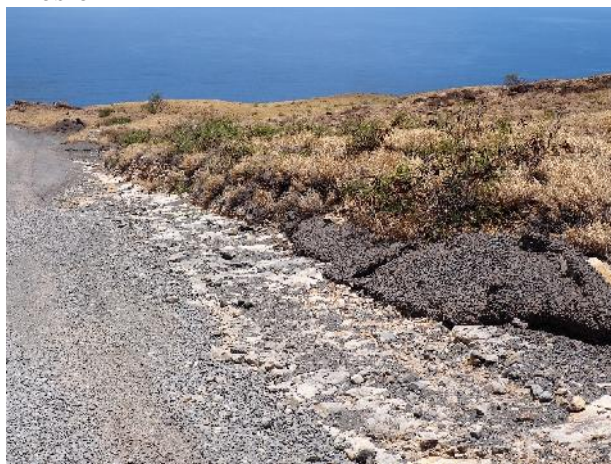
Gravel Loss in Swale

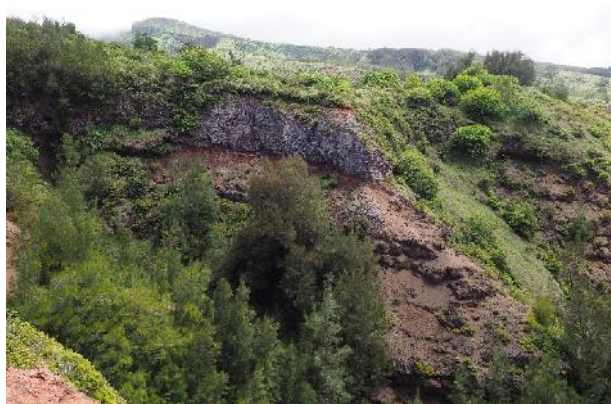
Loss of Vegetation

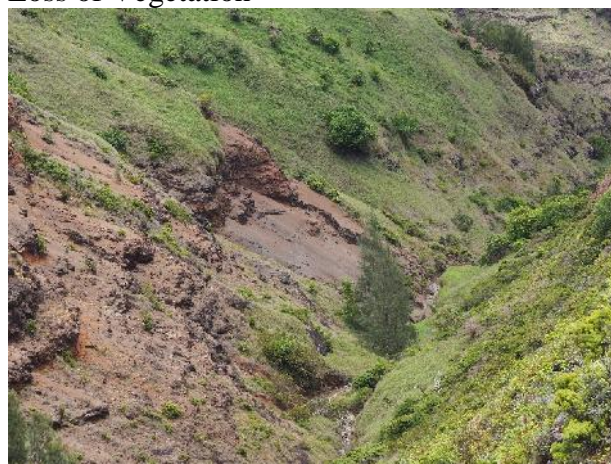
Land Slide into Gulch

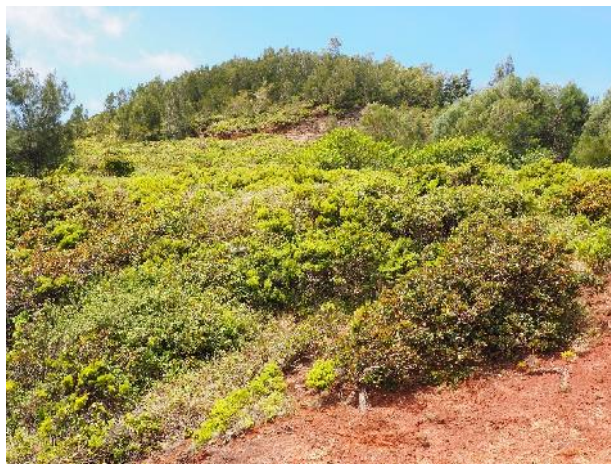
Bare Ground and Native Vegetation

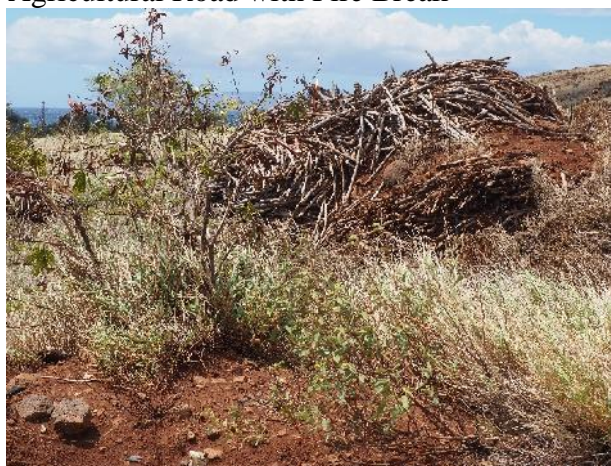
Old Sugar Cane Piled Near Ma'alaea Stream

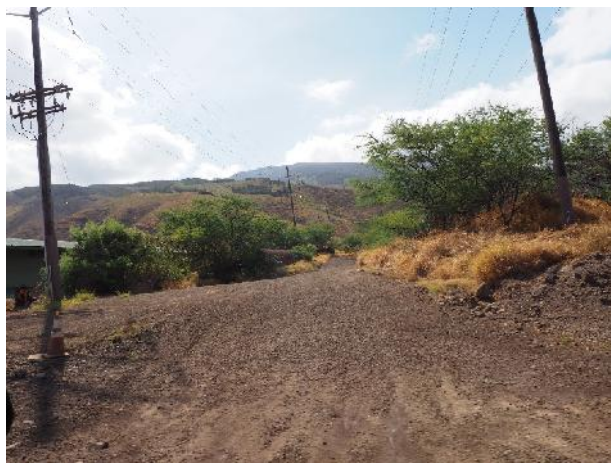
Gravel Roads Near Ditches

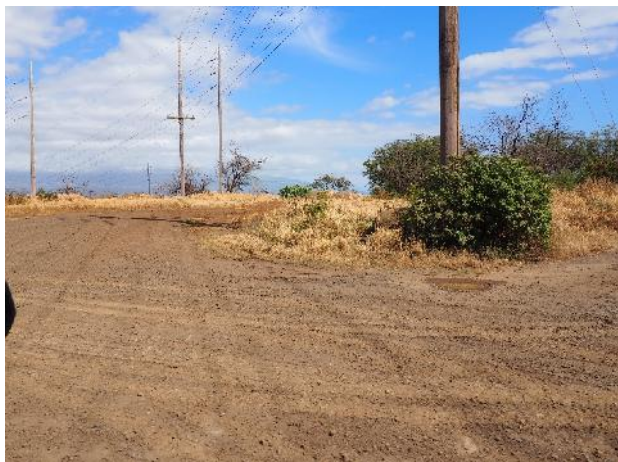
Gravel Roads Near Ditches

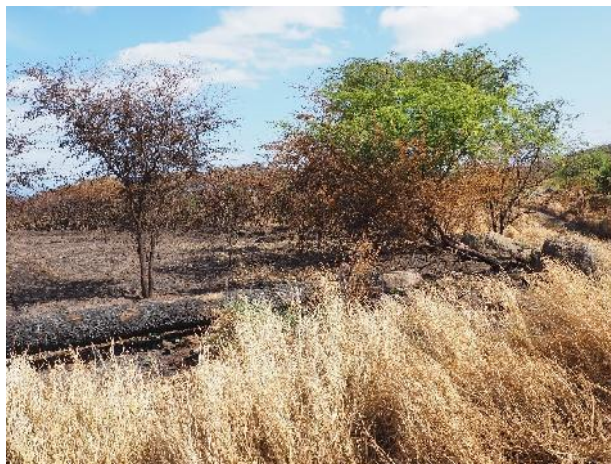
Evidence of Fire Near Entrance

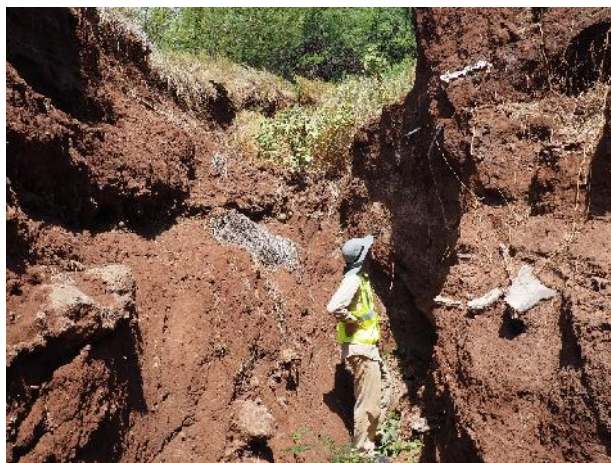
Channelization

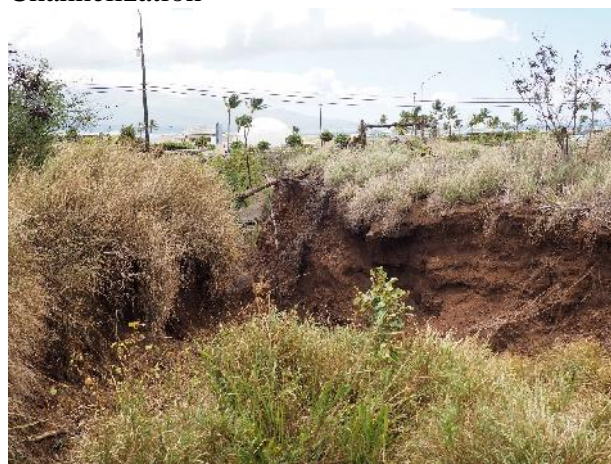
Head Cutting

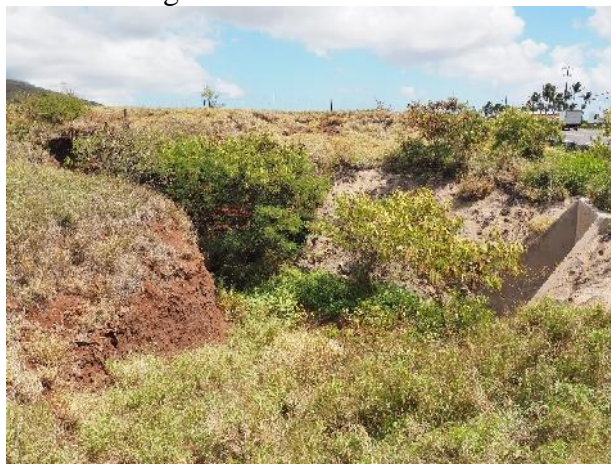
Culvert Backwall and Head Cutting

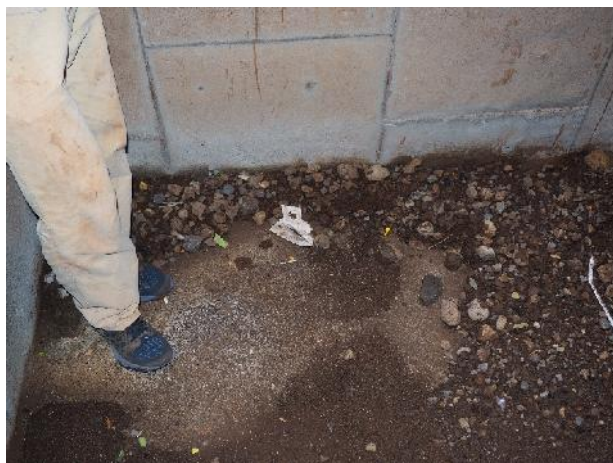
Sediment and Gravel in Culverts

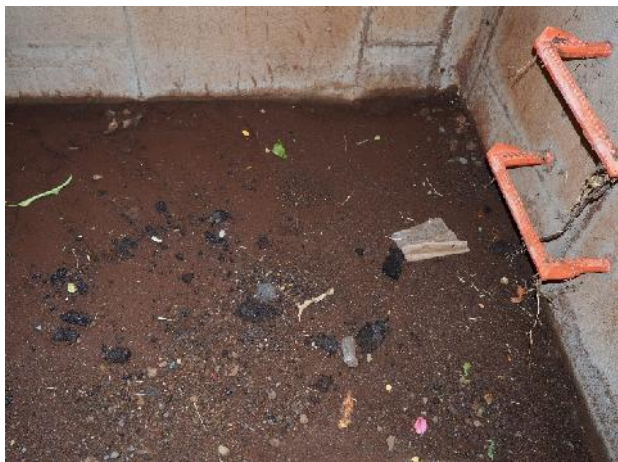
Sediment and Gravel in Culverts

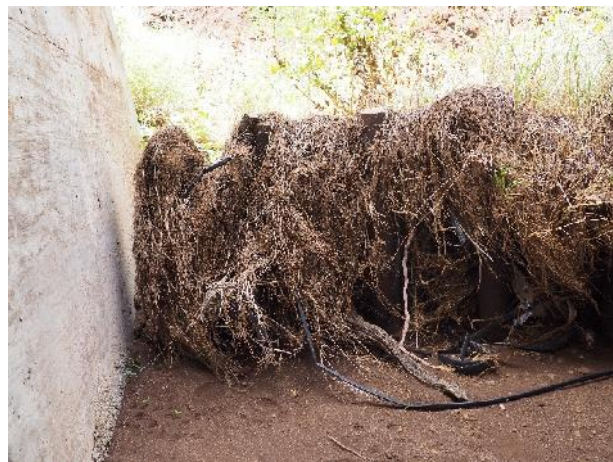
Vegetation at Entrance to Culvert

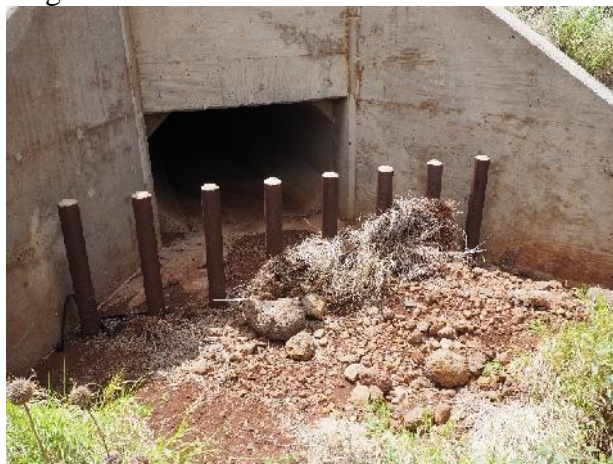
Sediment and Gravel at Culvert Entrance

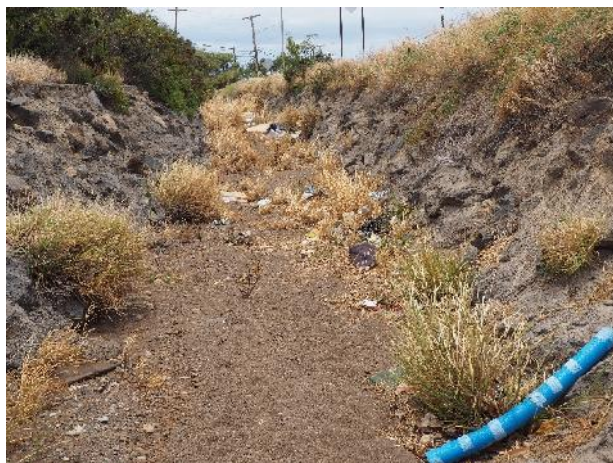
Rubbish in Ditch

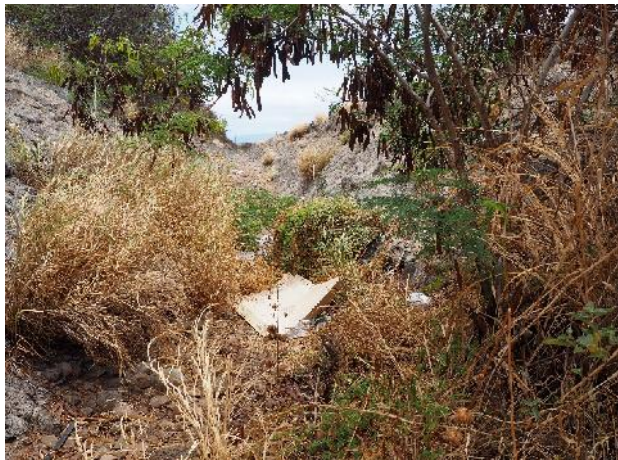
Vegetation and Rubbish in Ditch

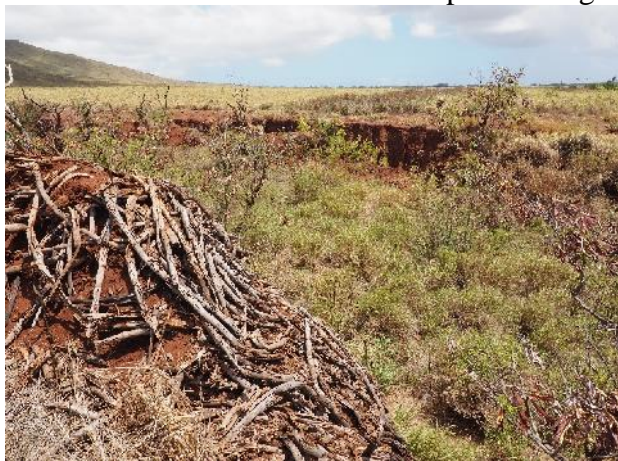
Sugar Cane Push Piles Near Gulch

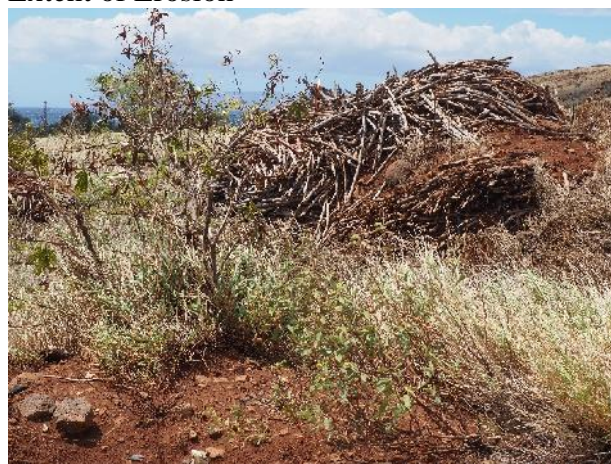
Sugar Cane Push Piles Near Gulch

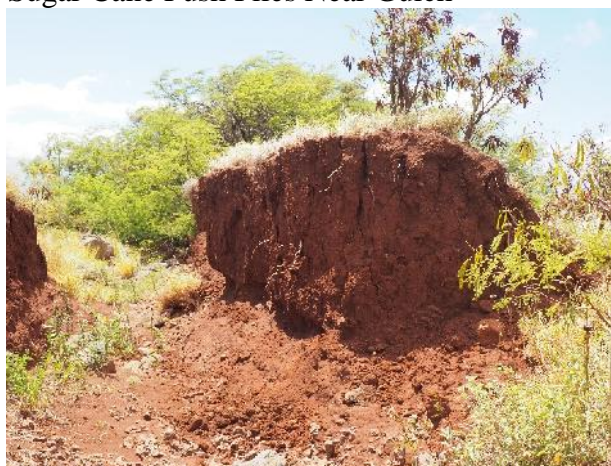
Evidence of Severe Erosion

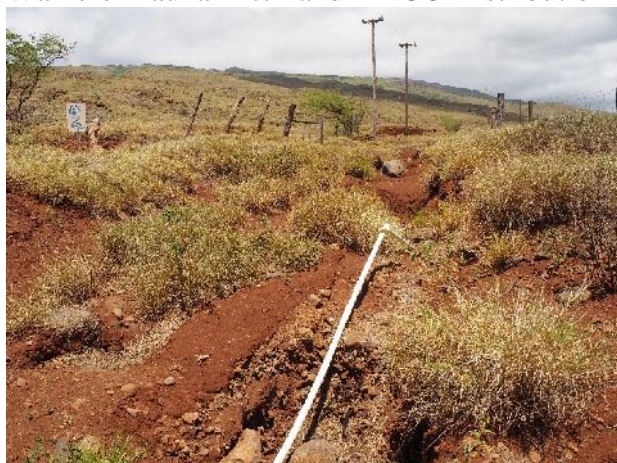
Channelization and Erosion

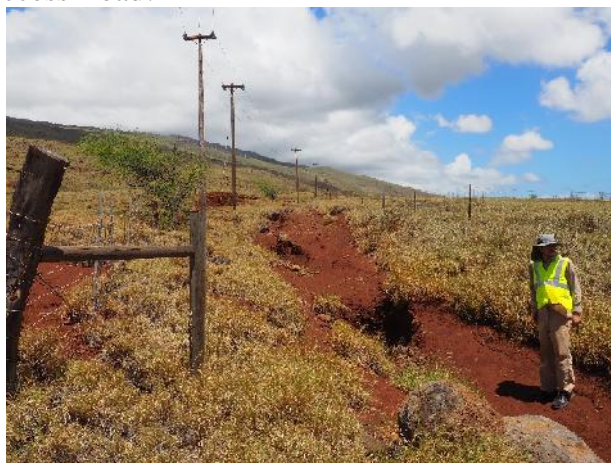
Channelization and Erosion

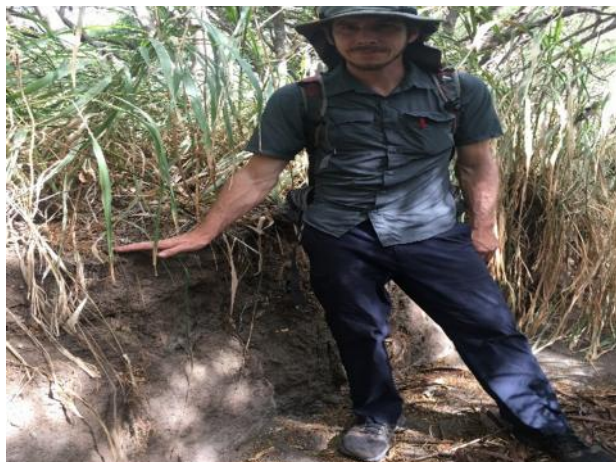
Bank Cutting within Pohakea

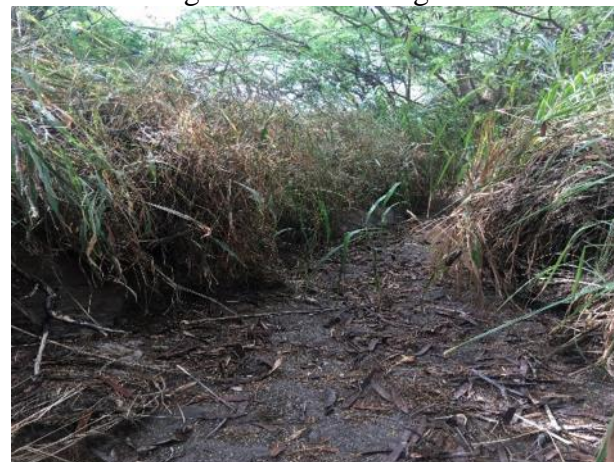
Vertical Stream Banks within Pohakea

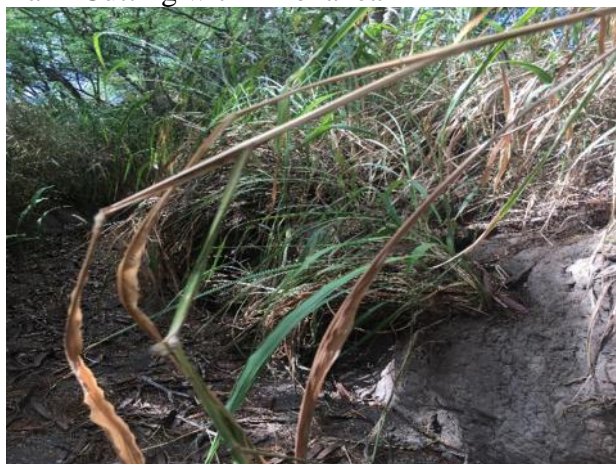
Exposed Stream Banks within Pohakea

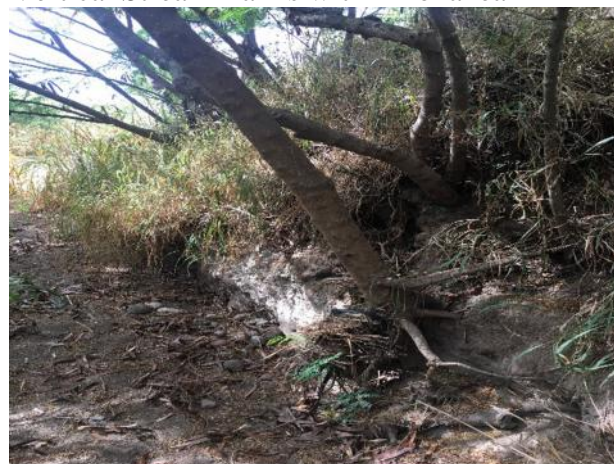
Wreck Lines and Eroded Bank within Pohakea

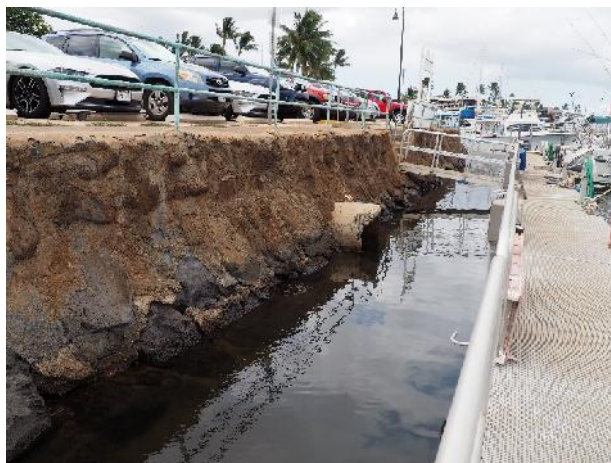
Culverts Discharging into Harbor

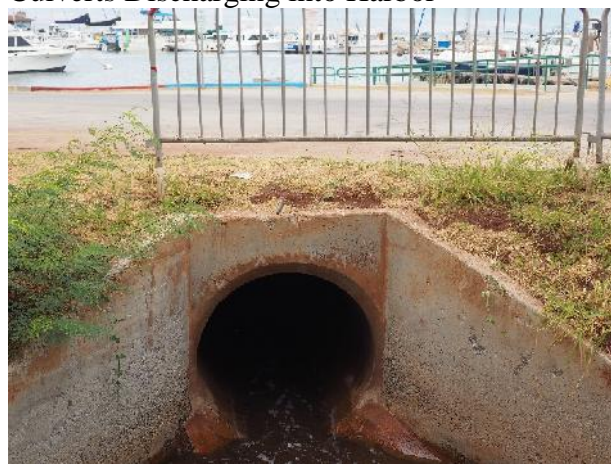
Culverts Discharging into Harbor

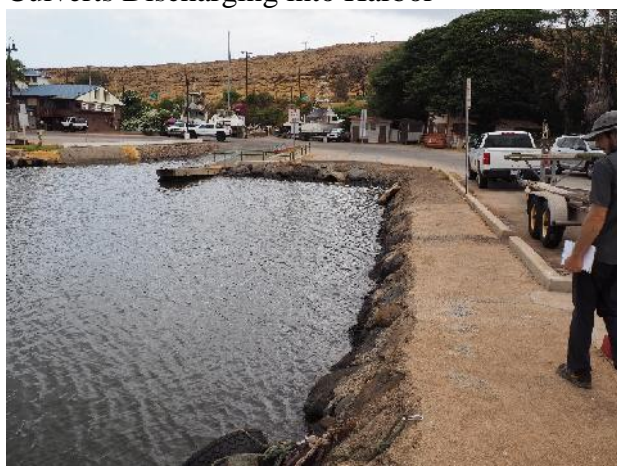
Culvert Outfall to Harbor

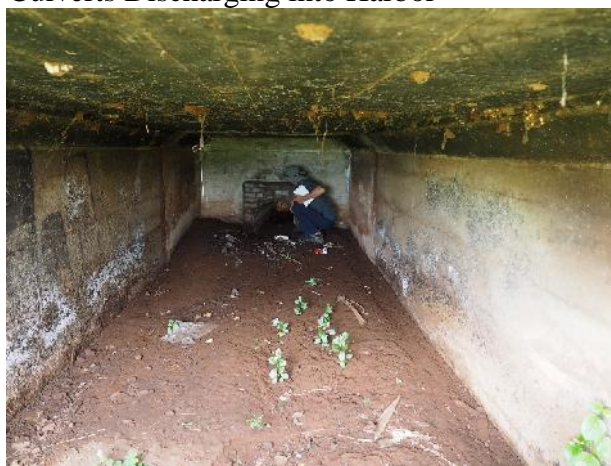
Substantial Sediment Deposition in Culvert

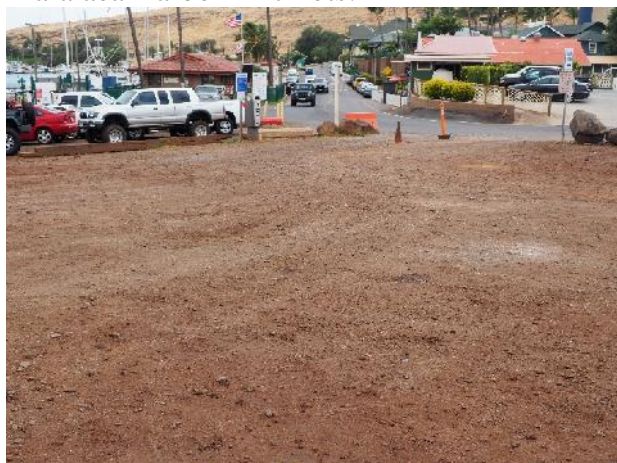
Dirt Lots with No BMPs in Place

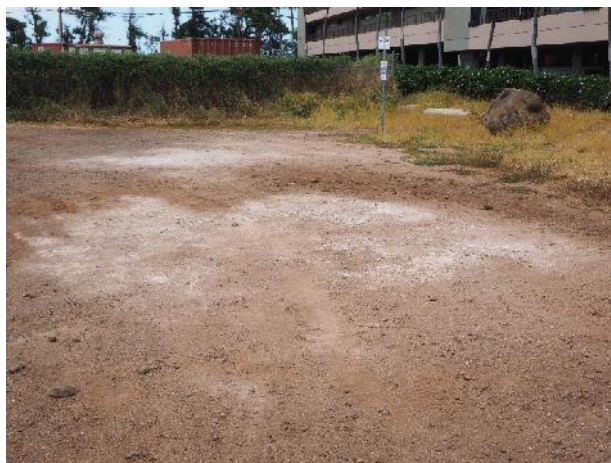
Dirt Lots with No BMPs in Place

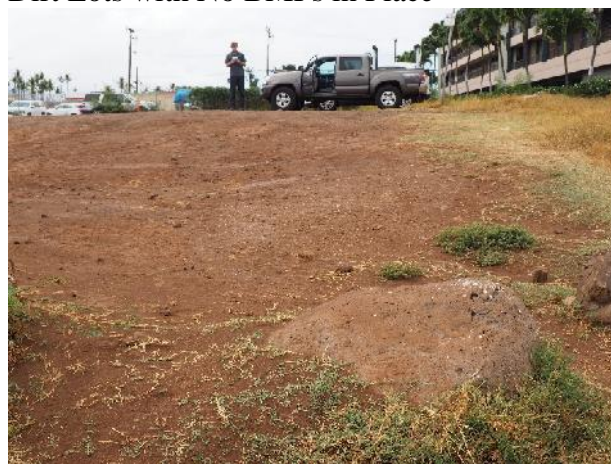
Dirt Lots with No BMPs in Place

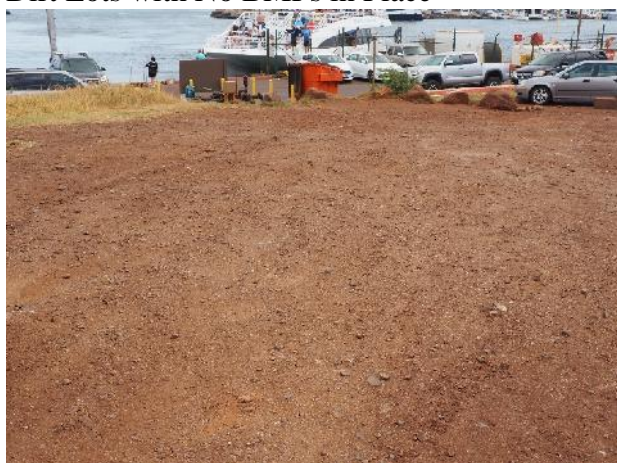
Dirt Lots with No BMPs in Place Next to Harbor

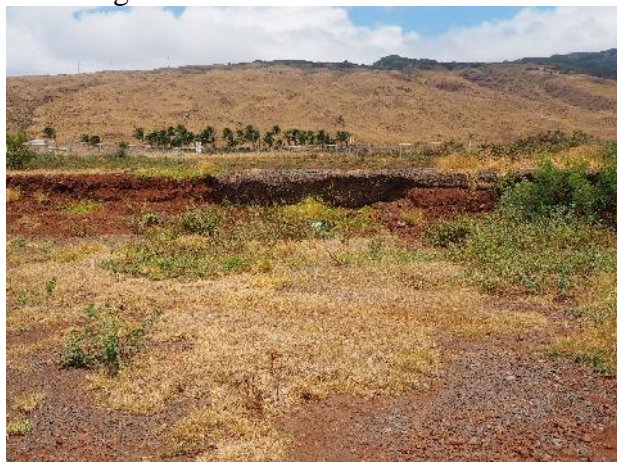
Eroded Sidewalls

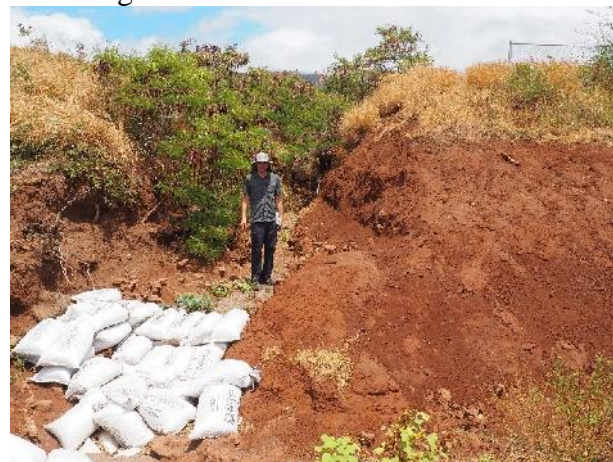
Sand Bags at Channel Outfall to Detention Basin
