**POHAKEA WATERSHED / MA ALAEA BAY  
MAUI COUNTY, HAWAII  
STORMWATER MANAGEMENT PLAN**

Maui Nui Marine Resource Council

November 16<sup>th</sup>, 2018

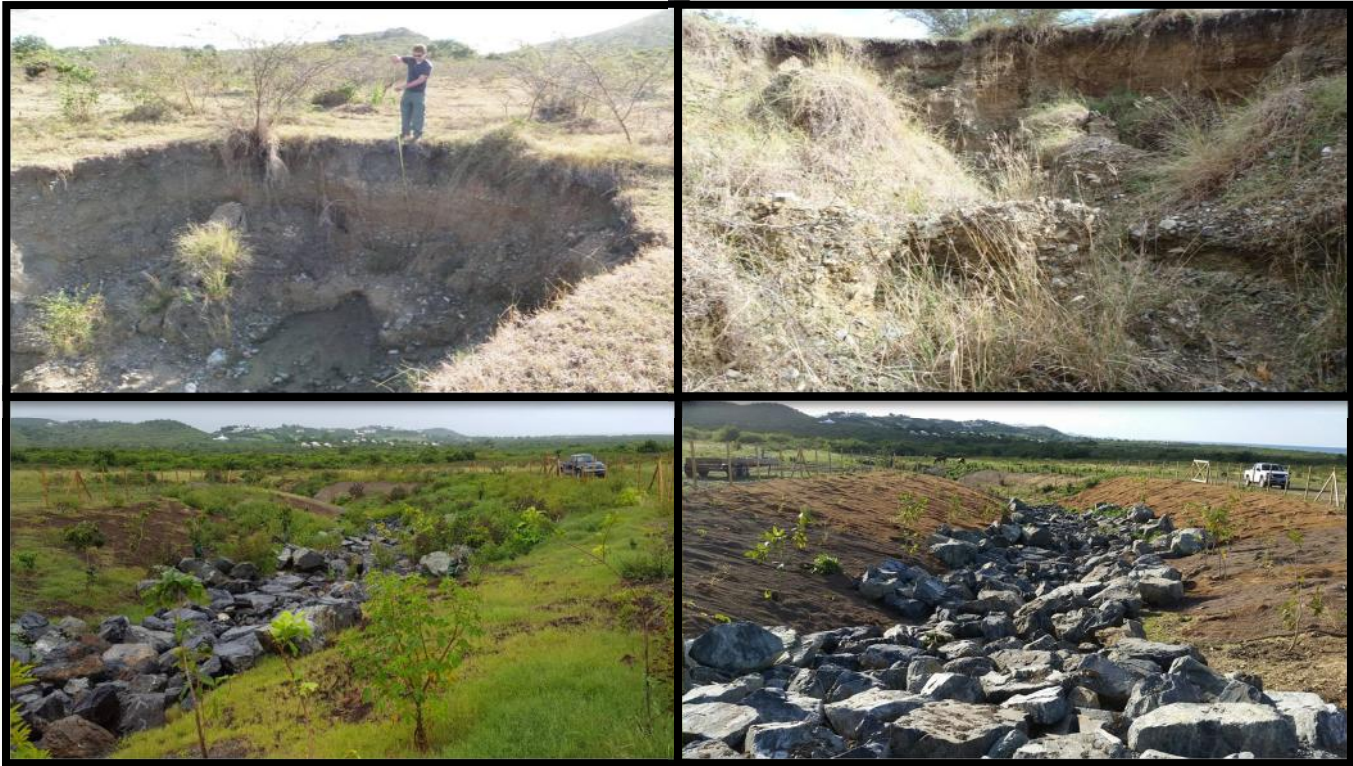
Figure 22. Examples of Head Cutting and Stabilization

An example of a head cut stabilization project in, St. Croix in the US Virgin Islands. The initial head cut (above) is very similar to those observed in Pohakea. The stabilized St. Croix project head cut (below), which uses step pools, boulders, and incorporates native plants, represents a possible solution for the Pohakea head cuts (Horsley Whitten, 2017).

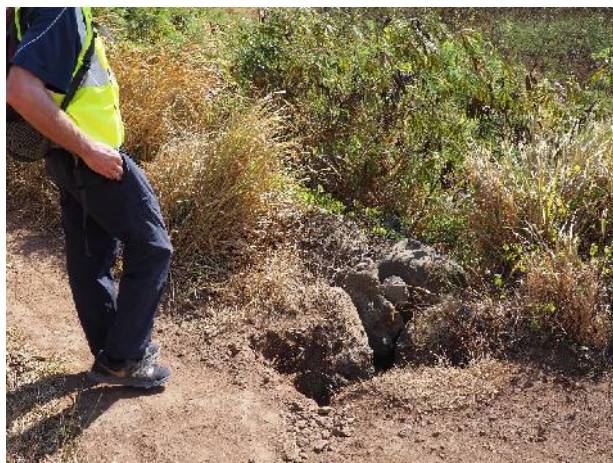
Erosion and Discharge from Road

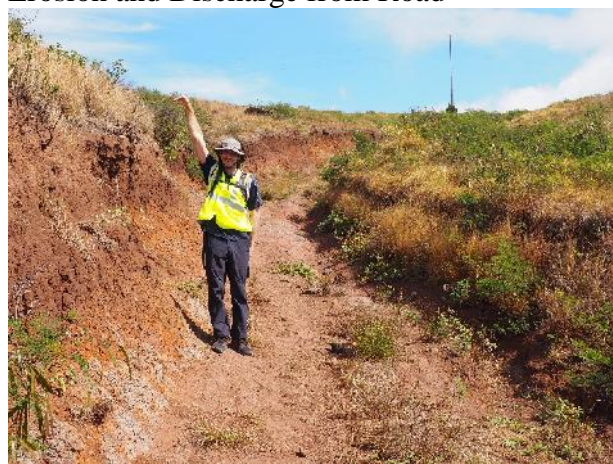
Exposed Soil Along Road

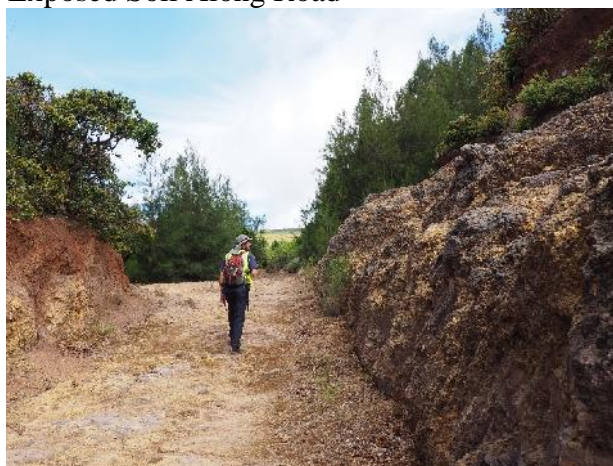
Exposed Soil Along Road

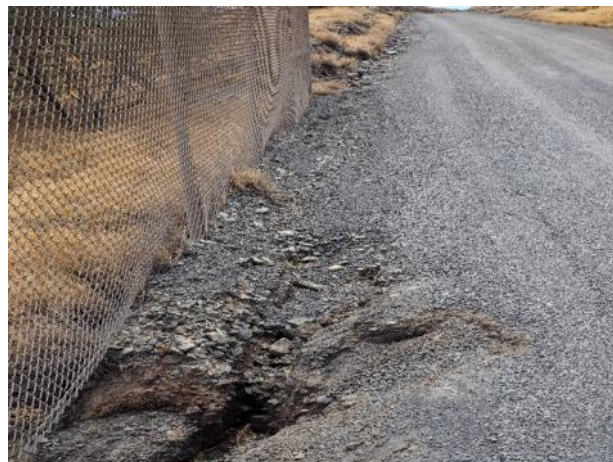
Erosion

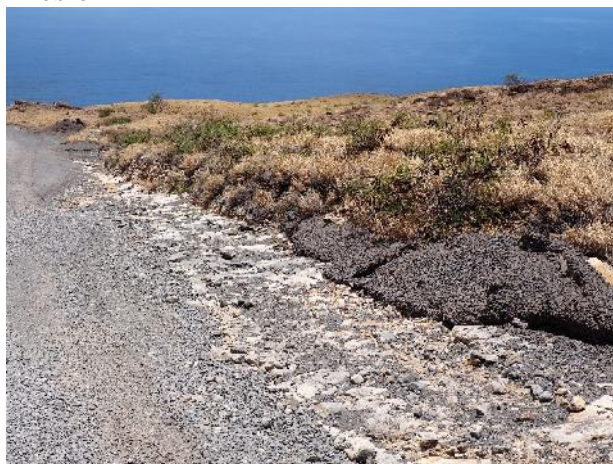
Gravel Loss in Swale

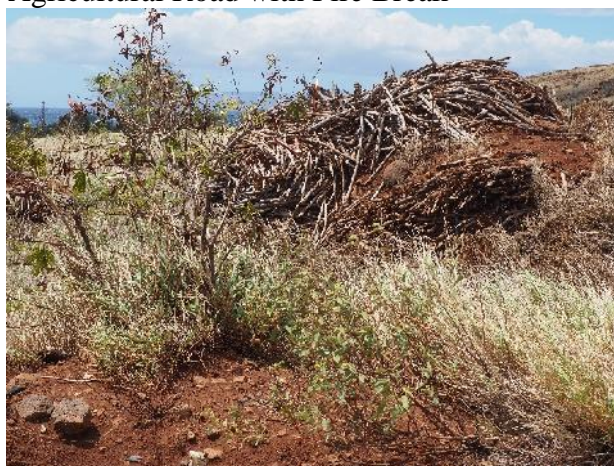
Old Sugar Cane Piled Near Ma'alaea Stream

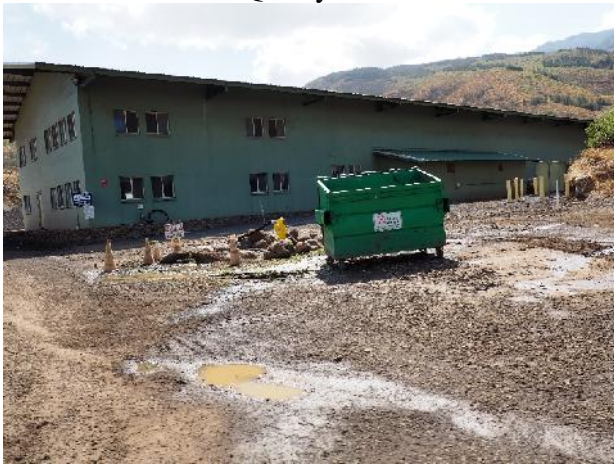
Gravel Roads with Mud and Erosion

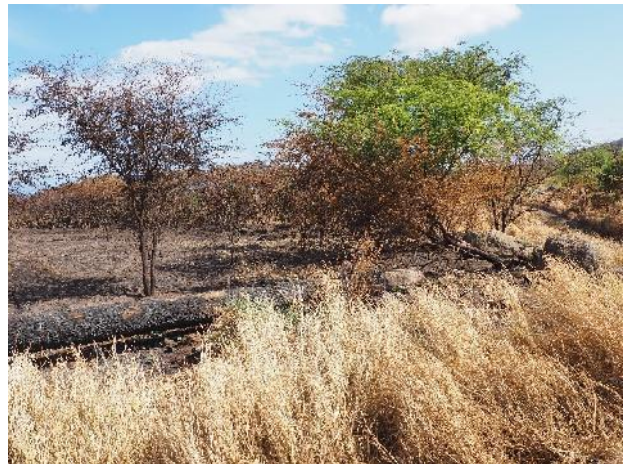
Evidence of Fire Near Entrance

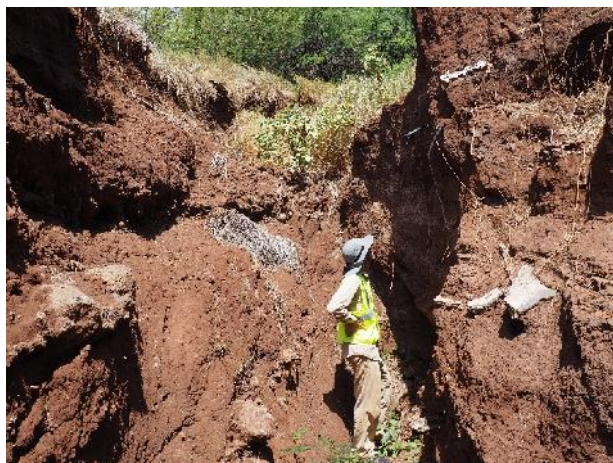
Channelization

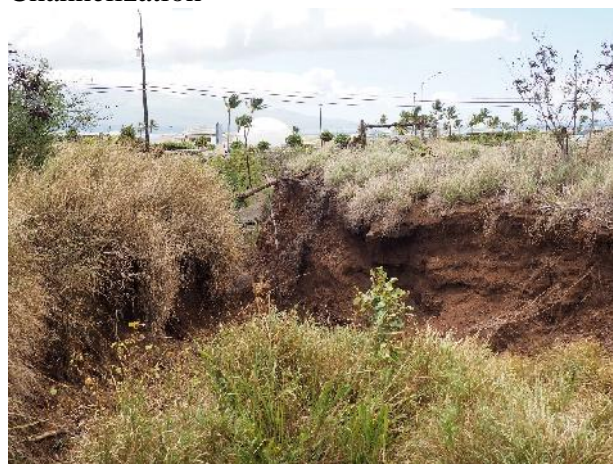
Head Cutting

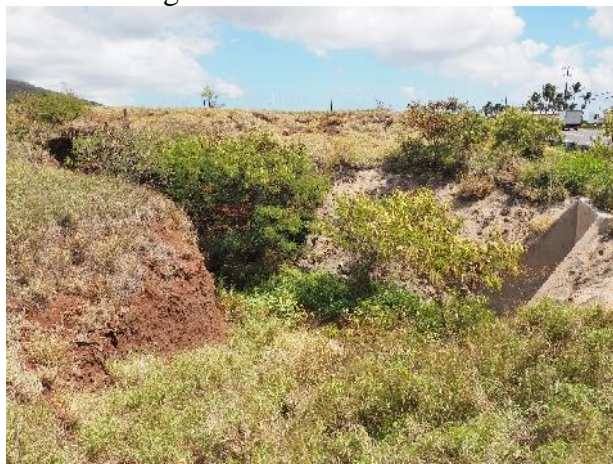
Culvert Backwall and Head Cutting

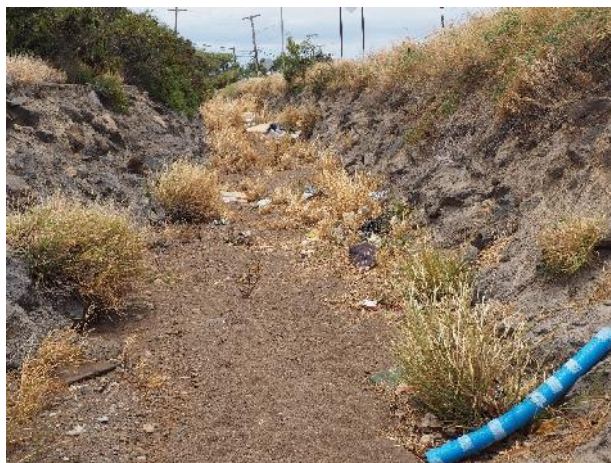
Rubbish in Ditch

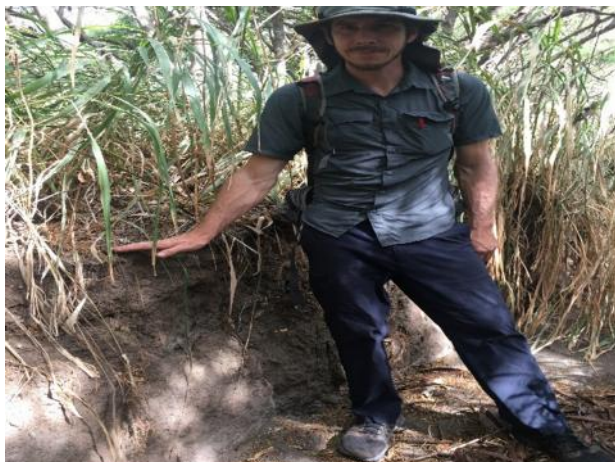
Bank Cutting within Pohakea

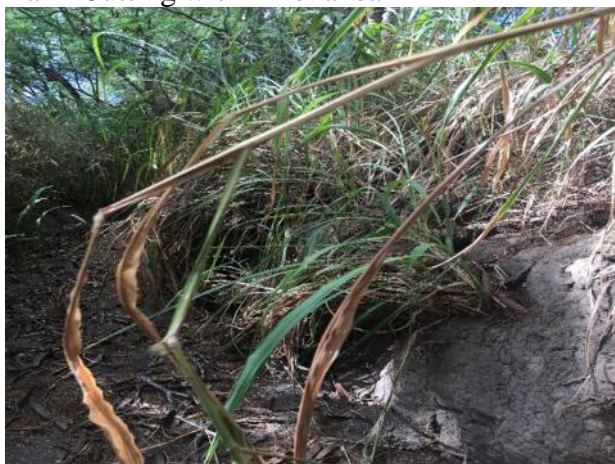
Exposed Stream Banks within Pohakea

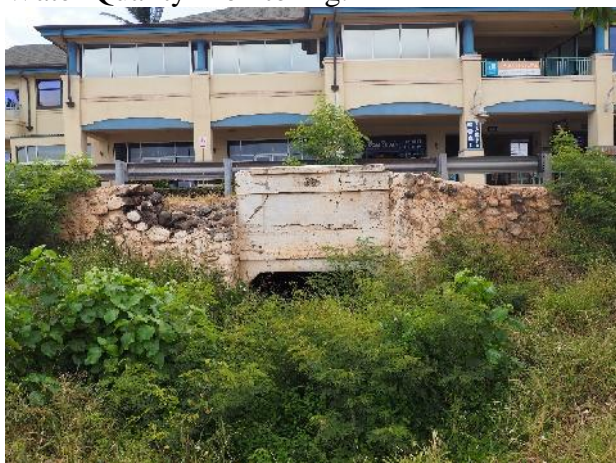
Ma alaea Triangle Outfall

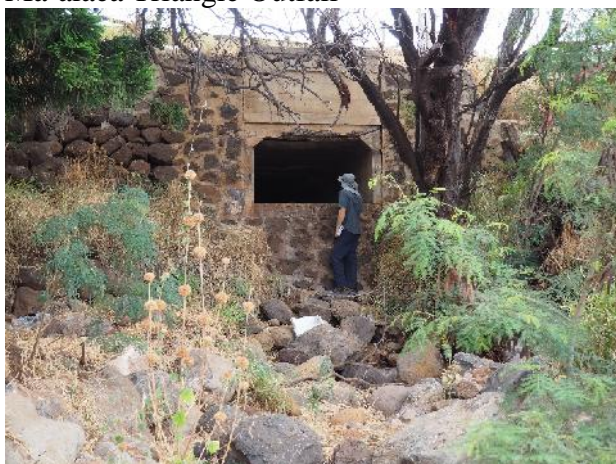
Culverts Discharging into Harbor

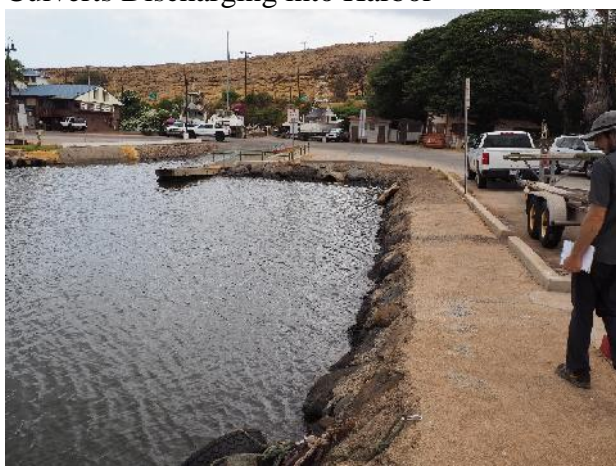
Culvert Outfall to Harbor

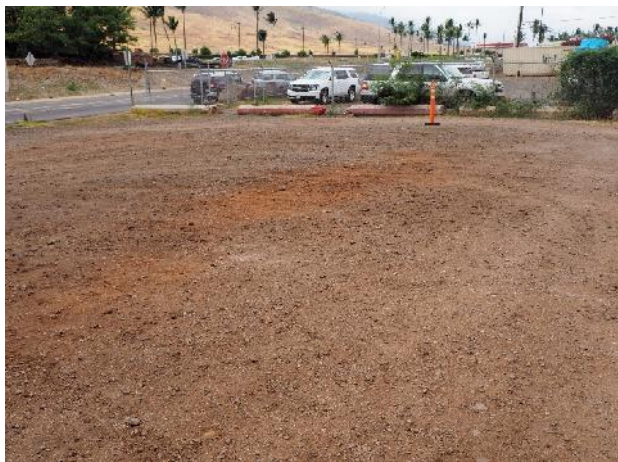
Dirt Lots with No BMPs in Place

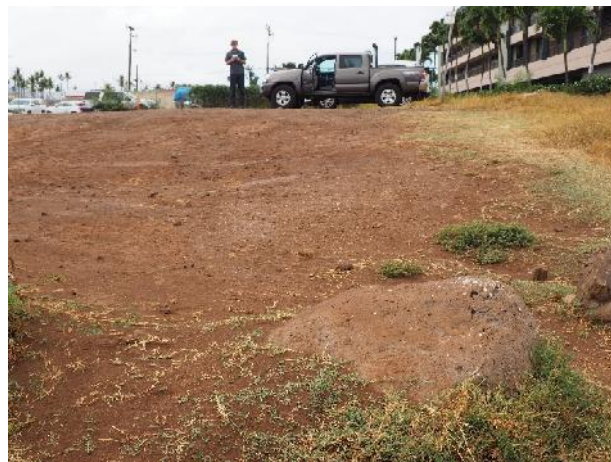
Dirt Lots with No BMPs in Place

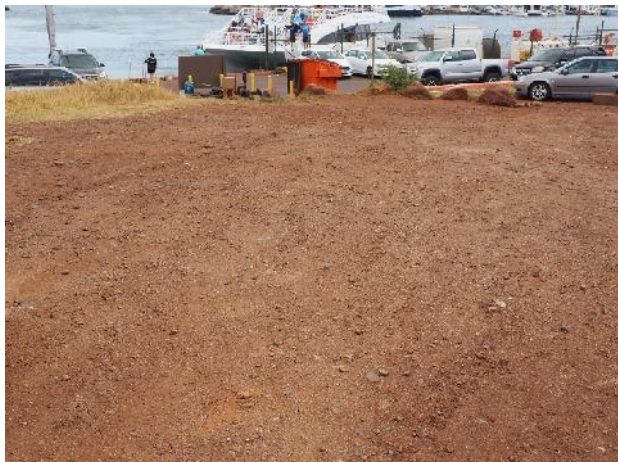
Dirt Lots with No BMPs in Place Next to Harbor

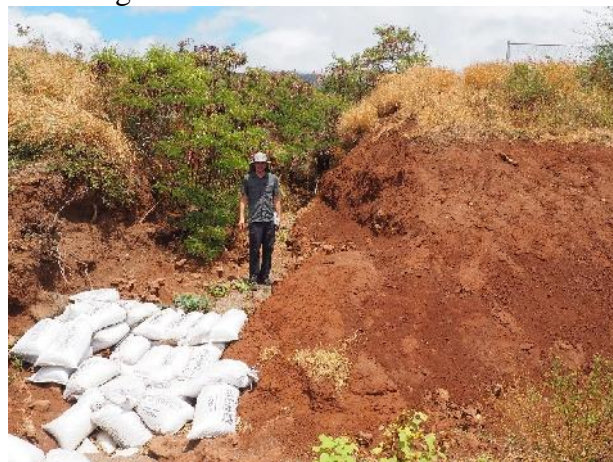
Sand Bags at Channel Outfall to Detention Basin
